> Impact rapid decrease water level

INTRODUCTION
RELATED TOPICS AND DELTA FACTS
MULTILAYER SAFETY STRATEGY
SCHEMATIC
TECHNICAL SPECIFICATIONS
MEASURES AND SOLUTIONS
COSTS AND BENEFITS
LESSONS LEARNED AND ON-GOING STUDY
KNOWLEDGE GAPS
REFERENCES/LINKS
EXPERIENCES
DISCLAIMER

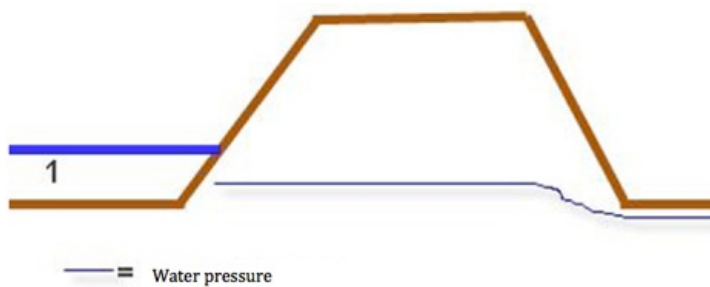
Situation 1: neutral situation

In situation 1, there is a normal level with low water pressure. The groundwater flow finds its way to the downstream polder level.

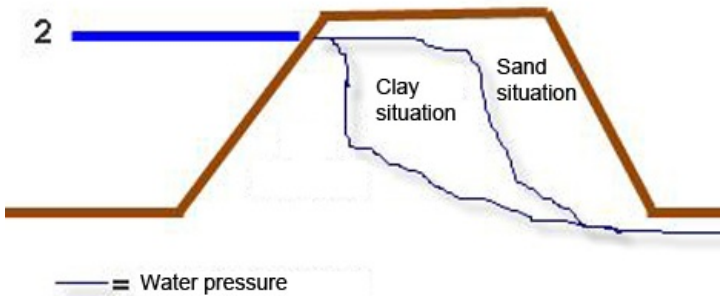
Situation 2: high water level

When the water level rises as a result of precipitation or increased water discharge, it creates higher water pressure, causing water to infiltrate the dike and the groundwater to rise to a higher level in the flood defence. One important factor is the permeability of the dike, which depends on the soil type, where clay is the least permeable, then peat and sand, respectively. The occurrence of shear instability (failure mechanism) is counteracted by the high river or storage basin level. The saturation level of a dike depends on the type of dike due to the complexity of the dike structure.

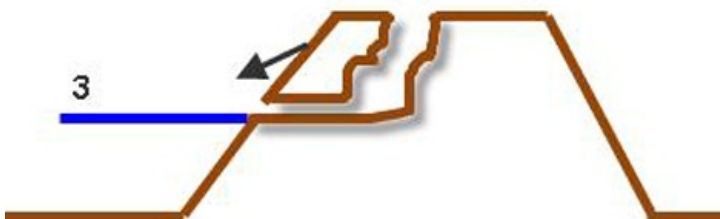
Situation 3: rapid water level decrease

In the event of a rapid decrease in the water level, the infiltrated water drains out of the dike body. The water has created extra weight in the dike and in combination with the water pressure, could cause different failure mechanisms:

- inward instability: large downward movement of a section of soil in response to a slip circle in the slope (situation in Figure 3)
- micro-instability; small-scale erosion of particles (washout). Problems related to micro-instability can occur at both the inner and outer slope.

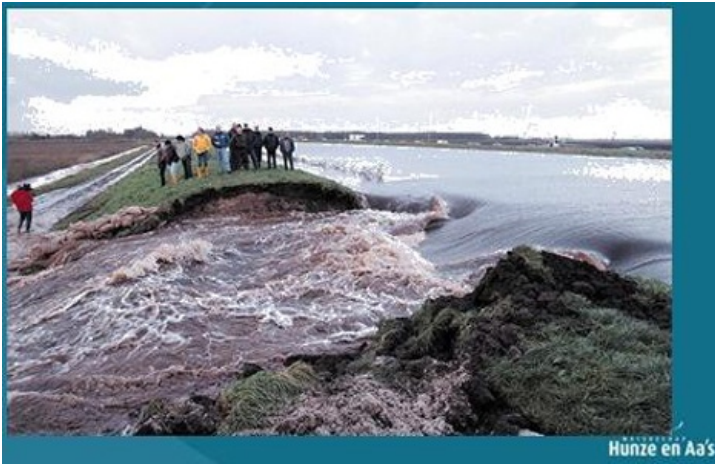
Picture of Tussenklappolder ' 98

A negative result may be the washout of the canal bed and the damage in the polder. In 1998, in Tussenklappolder, the dike across from the breach nearly collapsed as result of the soil washout, the soil was completely worn away and the toe of the dike across the street was almost torn away. Thus in the new designation the Tussenklappolder was not included as a storage area.

- Opening in dike to allow an area to be filled up quickly
- Dikes with cut-offs have been placed around vulnerable facilities in the storage area
- Model of the storage basin has been created to facilitate water level forecasts
- Sequence order prepared for the use of storage areas. Using the storage areas in a specific order seems to be very important, since the direction of the high water is determinative.
- Seepage walls erected and local reinforcements installed
- Overflow sills and revetment for the dike and canal bed to prevent washout of canal and polder side into the soil
